Manhole Inspection Summary

Manhole # S130__017MH

Insp Date: **3/24/08 1:47 PM**

Location Address: **2835 Frederick Av**

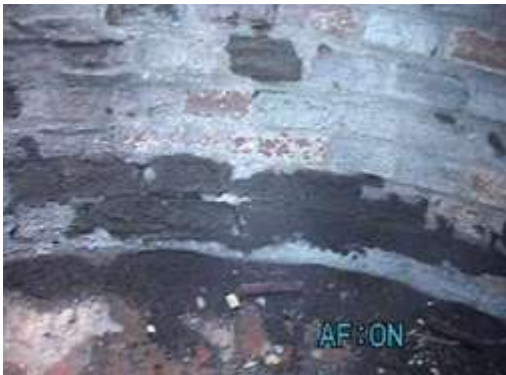
Defect 5

Infiltration: ☐ None ☐ Joint ☐ Cracks ☒ **Mortar** ☐ Roots ☒ **Wall**

infiltration barrel at barrel wall and mortar

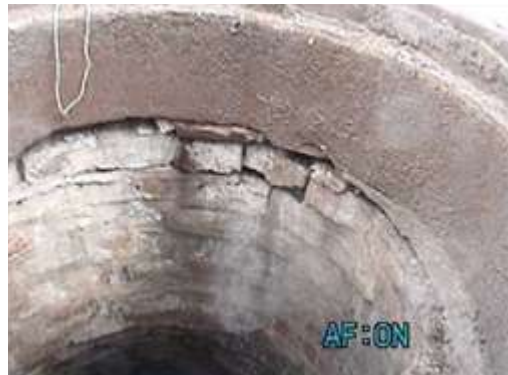
Defect 4

Condition: ☐ Sound ☐ Cracked ☐ Root Intrusion ☒ **Loose Brick** ☐ Deteriorated

loose brick missing mortar at chimney

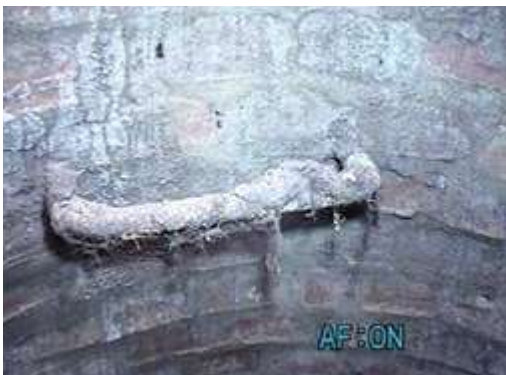
Defect 3

Steps Count: **6** Missing: **0** ☒ **Corroded**

steps corroded

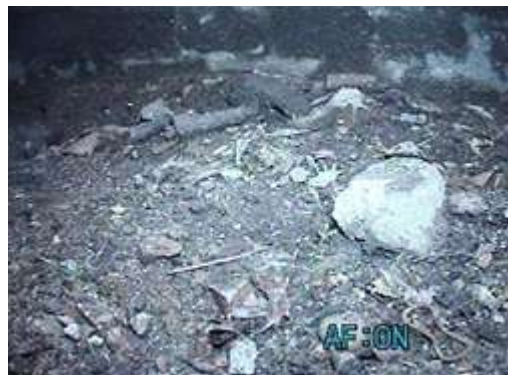
Defect 2

Condition: ☐ Sound ☐ Cracked ☐ Root Intrusion ☐ Deteriorated ☐ Leaks ☒ **Debris**

debris on bench

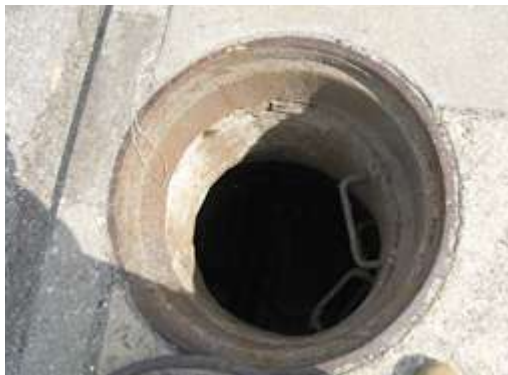
Defect 6

Frame Offset: **3** (in.) Condition: ☐ Sound ☐ Cracked ☒ **Leaks**

frame leaks-sheeting evidence, frame offset

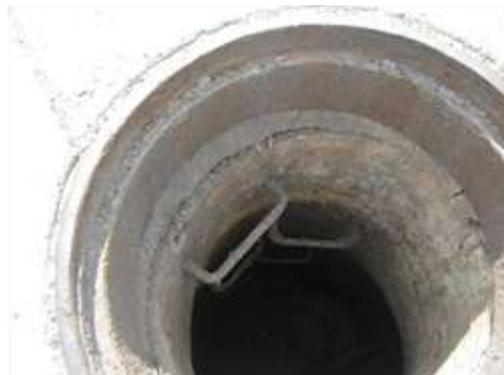
Defect 1

Infiltration: ☐ None ☒ **Joint** ☐ Cracks ☒ **Mortar** ☐ Roots ☐ Wall

joint & mortar infiltration at chimney

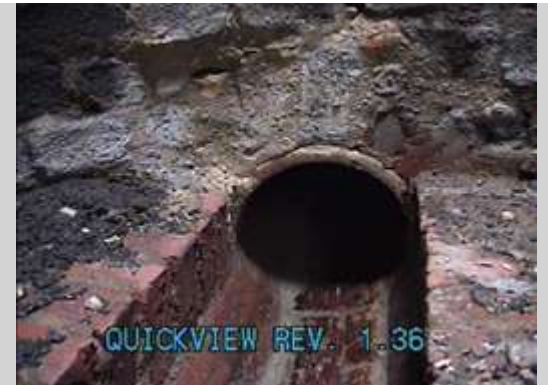
12 O'Clock Outflow

Pipe Height: **8.4** (in.) Rod and Bar (Angled)
Pipe Material: **Clay** ☐ Pipe Lined
Invert Depth: **10.62** (ft.) Flow Characteristics: **Fast**
Deposits: ☒ None ☐ Mud ☐ Sludge ☐ Debris ☐ Grease
Silt Depth: **0** (in.) Deposits Extent:
Infiltration: **None** Pipe Seal Cond: **Sound**

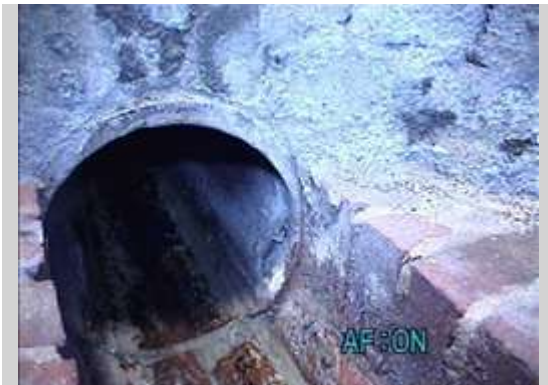
6 O'Clock Inflow

Pipe Height: **8.4** (in.) Rod and Bar (Angled)
Pipe Material: **Clay** ☐ Pipe Lined
Invert Depth: **10.22** (ft.) Flow Characteristics: **Fast**
Deposits: ☒ None ☐ Mud ☐ Sludge ☐ Debris ☐ Grease
Silt Depth: **0** (in.) Deposits Extent:
Infiltration: **None** Pipe Seal Cond: **Sound**
